**EXPERT REPORT OF JAMES MILLETTE, PHD (MVA) DATED 10/25/06**

Report of Results: MVA6504

Asbestos Fibers Released  
from Monokote

# A Close Examination of Asbestos-Containing Debris

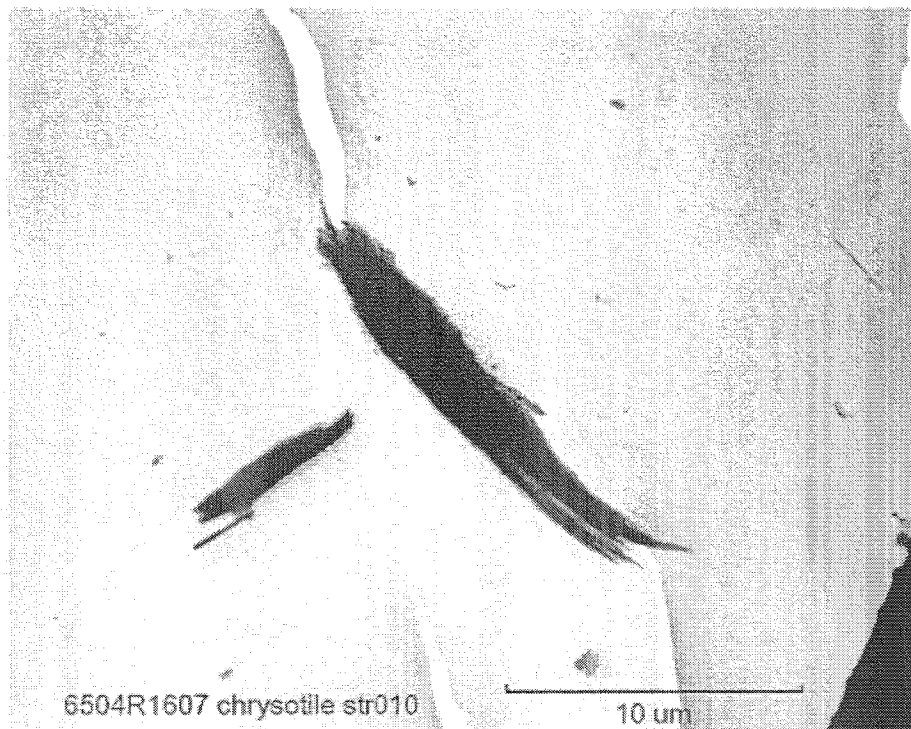
**Figure 1.** Transmission electron microscope image of chrysotile asbestos bundle (center) found in an air sample collected during disturbing Monokote fireproofing debris. There is no evidence of a gypsum coating or the "corn-dog" condition.

Analysis of the air samples collected while the Monokote fireproofing was disturbed showed that uncoated asbestos fibers were released into the air (Figures 1 - 9).

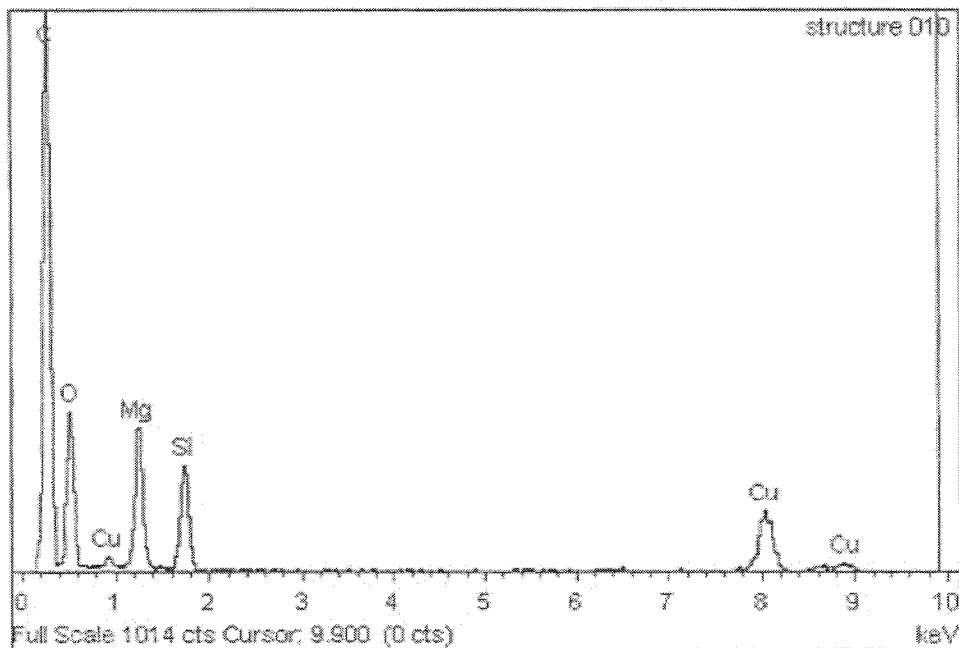
**Figure 2.** X-ray spectrum from chrysotile asbestos bundle shown in Figure 1. The magnesium and silicon are typical of chrysotile. The copper peaks are from the TEM system. No calcium or sulfur peaks indicative of gypsum are present.

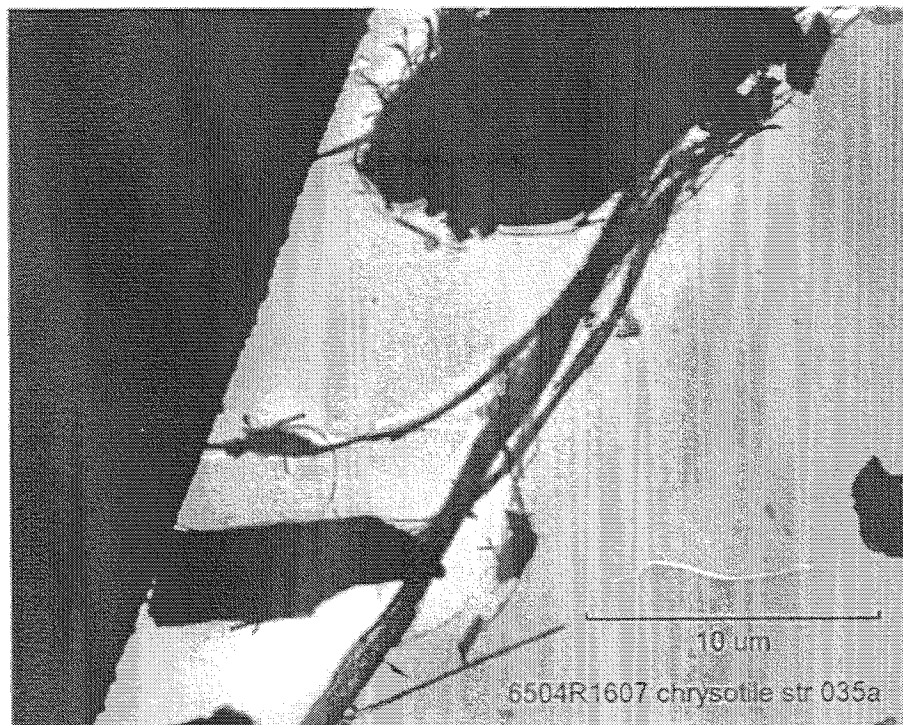
**Figure 3.** Transmission electron microscope image of chrysotile asbestos bundle (center) found in an air sample collected during disturbing Monokote fireproofing debris. There is no evidence of a gypsum coating or the "corn-dog" condition.

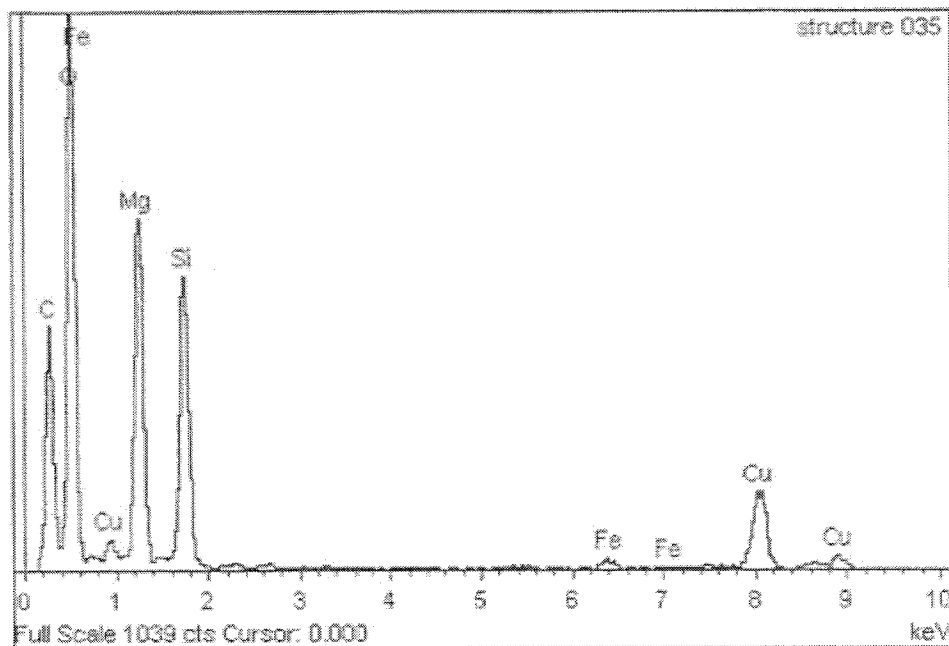
**Figure 4.** X-ray spectrum from chrysotile asbestos bundle shown in Figure 3. The magnesium and silicon are typical of chrysotile. The copper peaks are from the TEM system. No calcium or sulfur peaks indicative of gypsum are present.

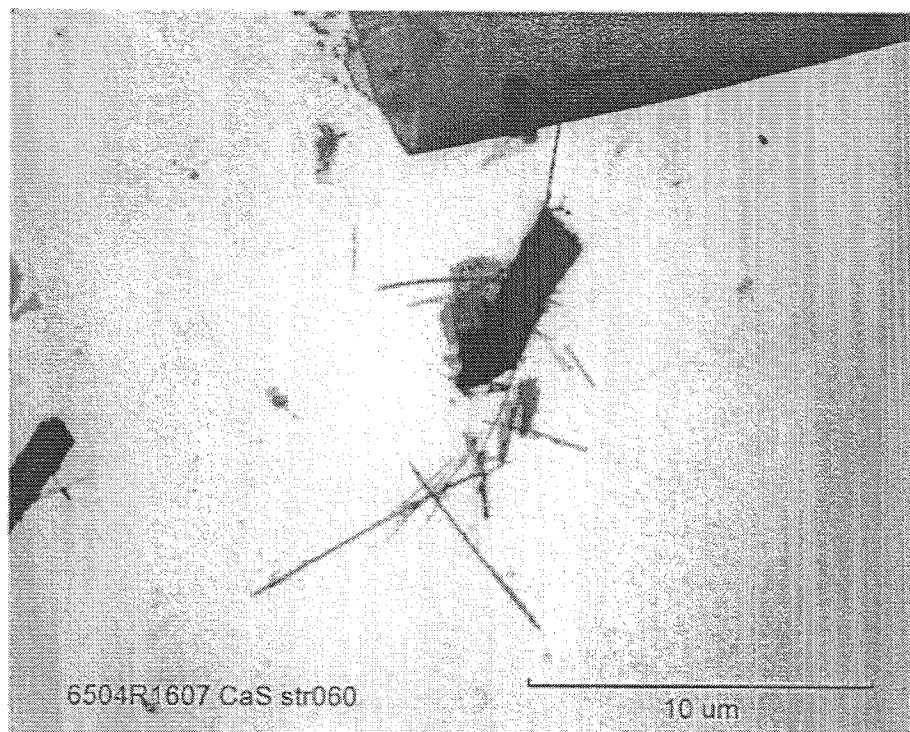
**Figure 5.** Transmission electron microscope image of a matrix of gypsum particle (larger dark elongated particle in the middle of the image, vermiculite (a thin plate that appears to be lying under the gypsum particle) and uncoated chrysotile asbestos fibers.

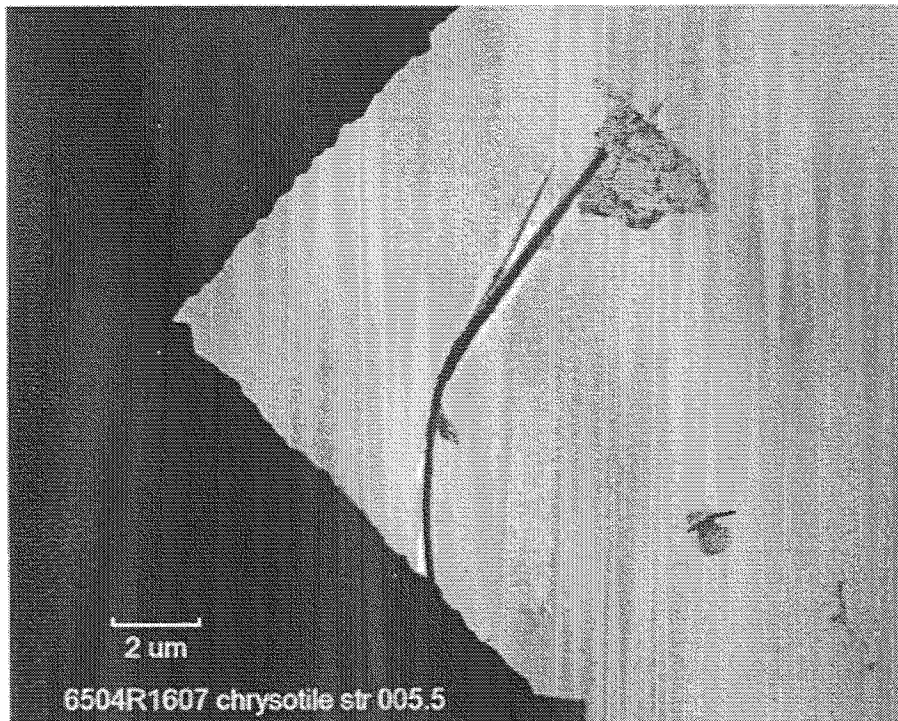
**Figure 6.** Transmission electron microscope image of chrysotile asbestos bundle (center) found in an air sample collected during disturbing Monokote fireproofing debris. There is no evidence of a gypsum coating or the "corn-dog" condition. A piece of vermiculite is seen at the top of the chrysotile fiber. There is no way to know whether the vermiculite particle and the chrysotile bundle were associated in the air or one landed on top of the other on the filter and therefore were individual particles in the air.

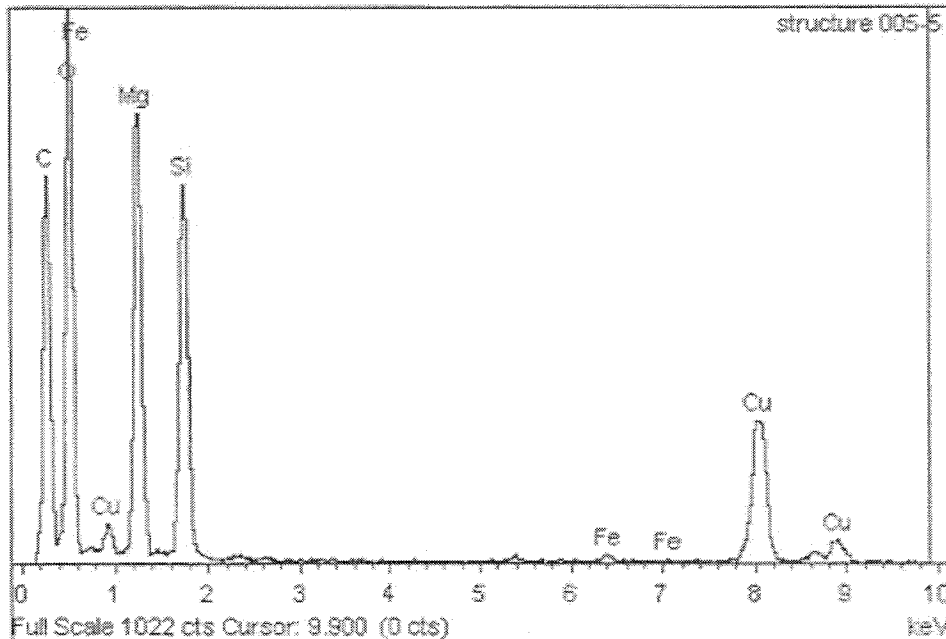
**Figure 7.** X-ray spectrum from chrysotile asbestos bundle shown in Figure 6. The magnesium and silicon are typical of chrysotile. The copper peaks are from the TEM system. No calcium or sulfur peaks indicative of gypsum are present.

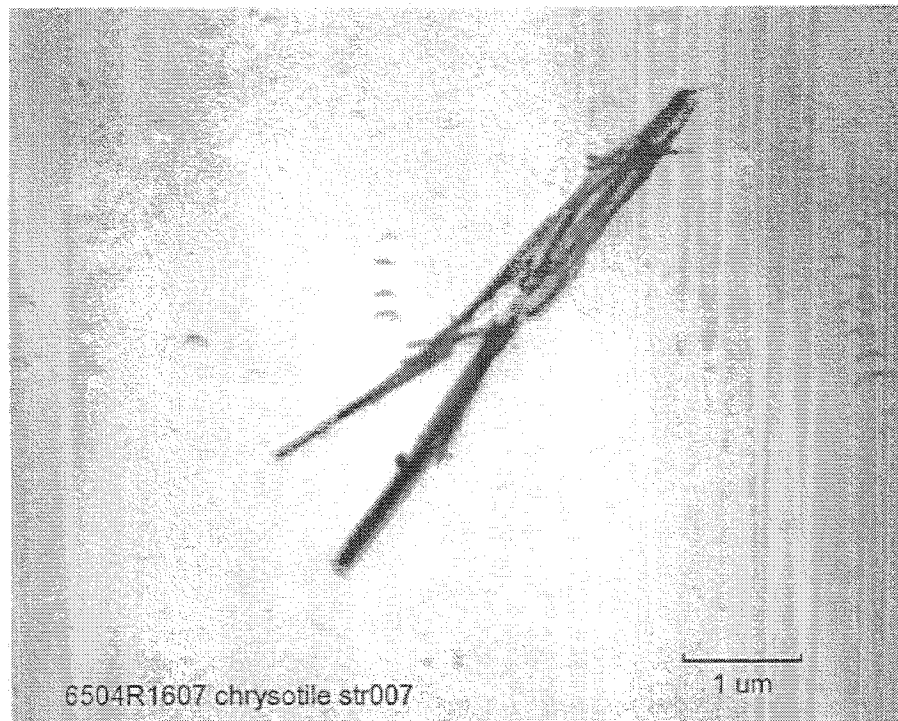
**Figure 8.** Transmission electron microscope image of chrysotile asbestos bundle (center) found in an air sample collected during disturbing Monokote fireproofing debris. There is no evidence of a gypsum coating or the "corn-dog" condition.

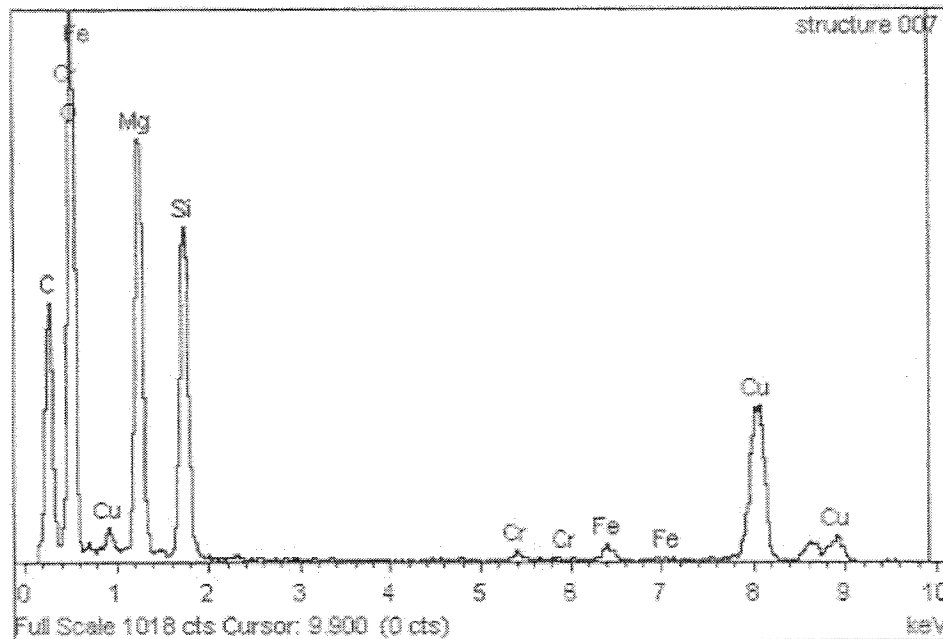
**Figure 9.** X-ray spectrum from chrysotile asbestos bundle shown in Figure 8. The magnesium and silicon are typical of chrysotile. The copper peaks are from the TEM system. No calcium or sulfur peaks indicative of gypsum are present.

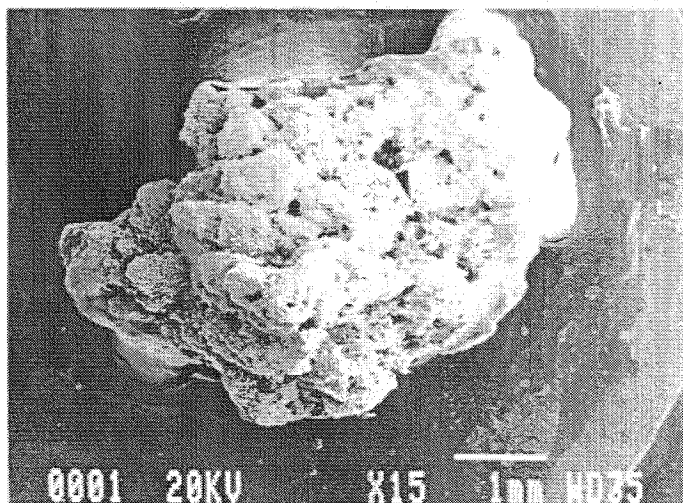
*Figure 1. Low magnification SEM micrograph of fireproofing material released (Bar=1mm).*

Examination was performed by scanning electron microscopy-energy dispersive spectroscopy (SEM-EDS). The SEM-EDS system consisted of a JEOL Model 820 with a Tracor Northern 5402 X-ray system. At a low magnification (15x) the particle appeared to be an open, airy aggregate covered in part by a binder material (*Figure 1*). At higher magnifications, chrysotile bundles and individual chrysotile fibers as confirmed by EDS were observed on the aggregate surface and protruding from the aggregate surface. *Figure 2* (arrow in *Figure 1*) shows a chrysotile bundle protruding from the surface, which at this low magnification appears to be completely

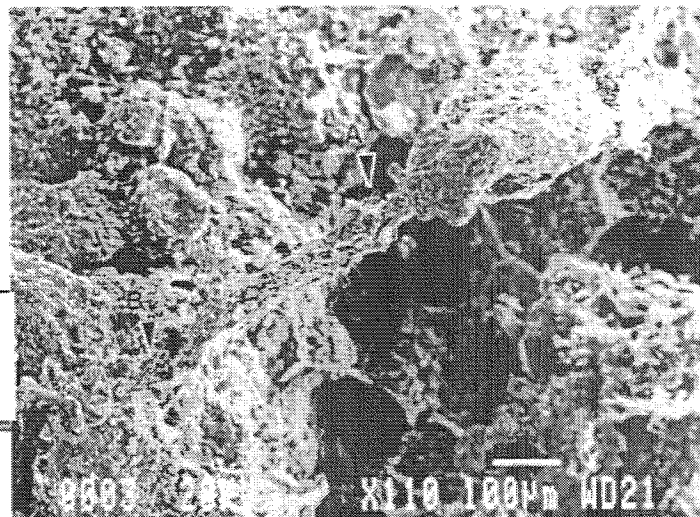
Figure 2. Higher magnification of chrysotile bundle indicated by arrow in Figure 1 (Bar=100µm).

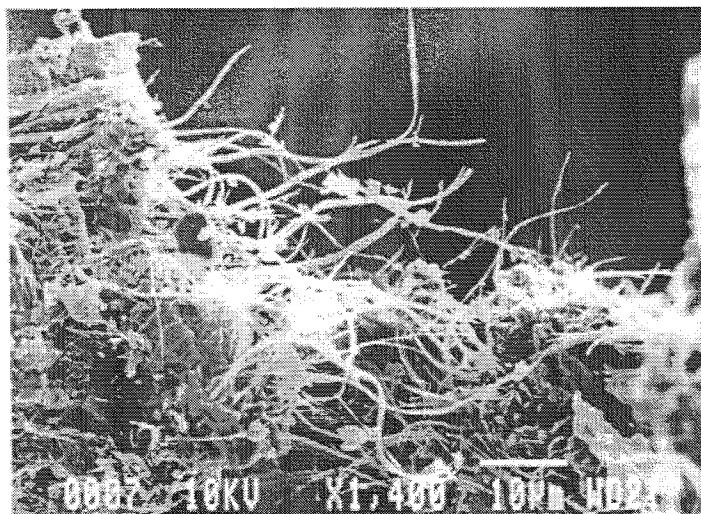
Figure 3. Higher magnification of area indicated by arrow "A" in Figure 2 (Bar=10µm).

covered by binder material. However, at a higher magnification, (1,400x, *Figure 3*), it was found that while binder particles are intermixed with the chrysotile fibers, chrysotile can be observed throughout the bundle free from binder material. *Figure 4* is the EDS spectrum obtained from chrysotile fibers in *Figure 3* [Magnesium (Mg) and Silicon (Si)]. *Figure 5* (arrow "B" in *Figure 2*) shows gypsum particles at the base of the chrysotile bundle in *Figure 2*. *Figure 6* is the EDS spectrum obtained from a gypsum particle in *Figure 5* [Sulfur (S) and Calcium (Ca)]. Hundreds of fine, uncoated chrysotile fibers were observed on all the aggregate surfaces.

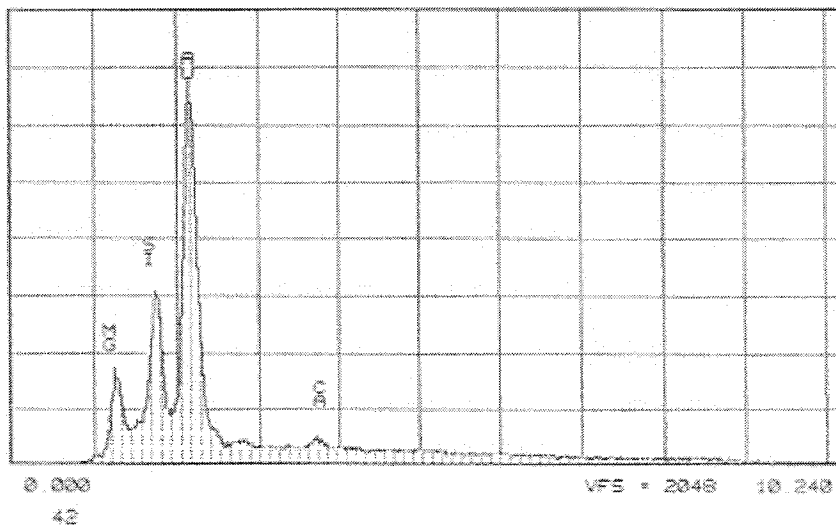
Figure 4. X-ray Energy Dispersive Analysis Spectrum (EDS) of chrysotile indicated by arrow in Figure 3. Magnesium (Mg) and silicon (Si) are from the chrysotile fiber. Gold (Au) comes from the gold coating preparation of the sample for SEM analysis.

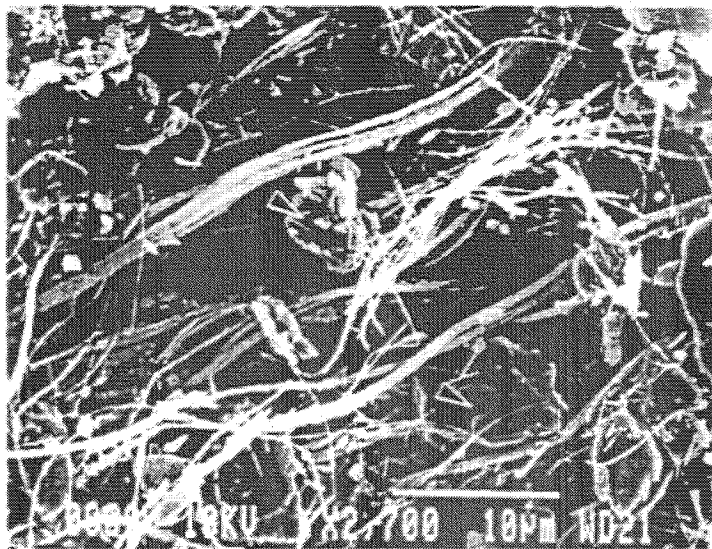
Figure 5. Gypsum particles among chrysotile fibers in area indicated by arrow "B" in Figure 2 (Bar=10µm).

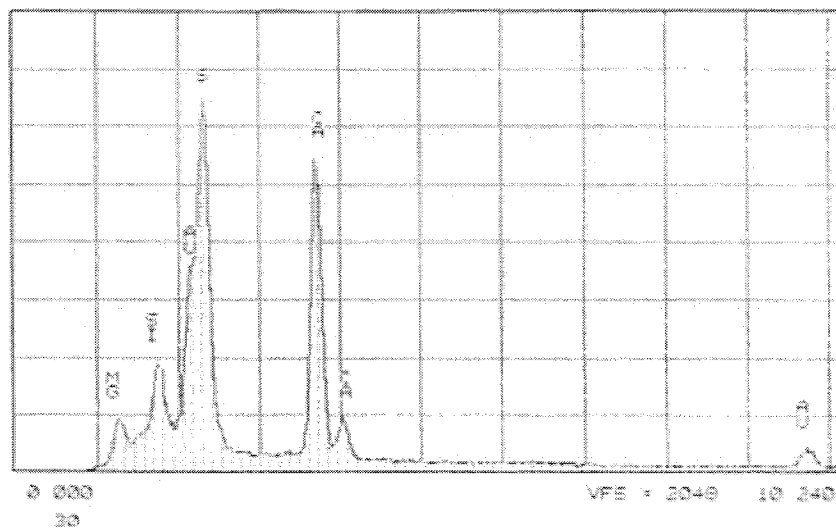
Figure 6. EDS of gypsum particles in Figure 5. Sulfur (S) and calcium (Ca) are from the gypsum particles. Mg and Si from nearby chrysotile. Gold (Au) from gold coating on specimen for SEM analysis.
